***Brookfield Town House***

***Critical Needs Assessment***

***Salmon Falls Architecture, Inc.***

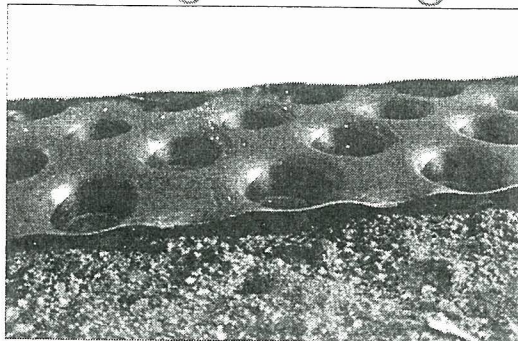
## Drainage Matting

- Creates a drainage space under CleanSpace® for water to flow beneath.
- Adds durability, puncture resistance, and a thermal break.

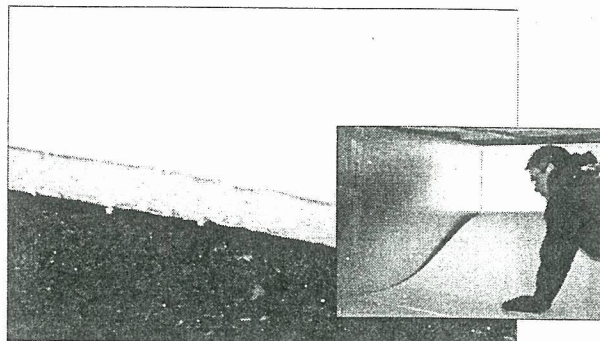
## TerraBlock™

- ¾" Flexible foam insulation with vapor barrier on both sides.
- Insulates your crawl space floor beneath CleanSpace®.

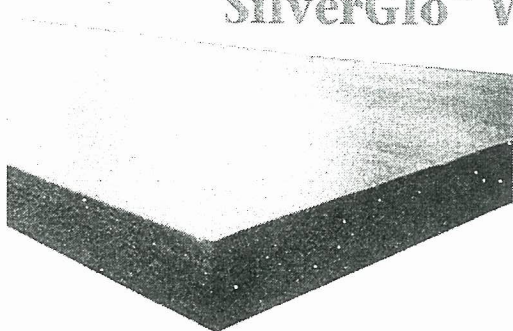
## SilverGlo™ Wall Insulation

**SilverGlo™** panels look different because they ARE different. Tiny graphite particles permeate its foam insulation to give it that silver/gray shine. These tiny particles reflect heat and lower the material's conductivity for superior **R value** per inch. In addition to resisting heat conduction, **SilverGlo™** boasts a radiant barrier, which reflects heat back into your crawl space for ultimate energy savings.

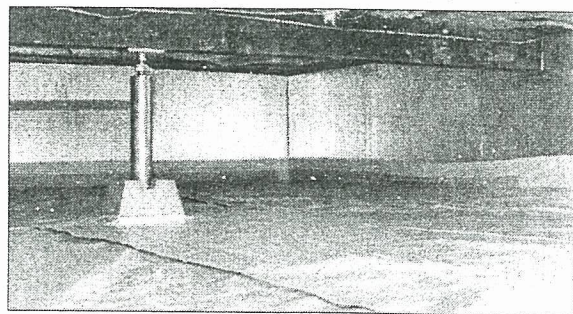
**SilverGlo™** can also be installed on the perimeter of your floor framing system (rim joist) for maximum energy savings.

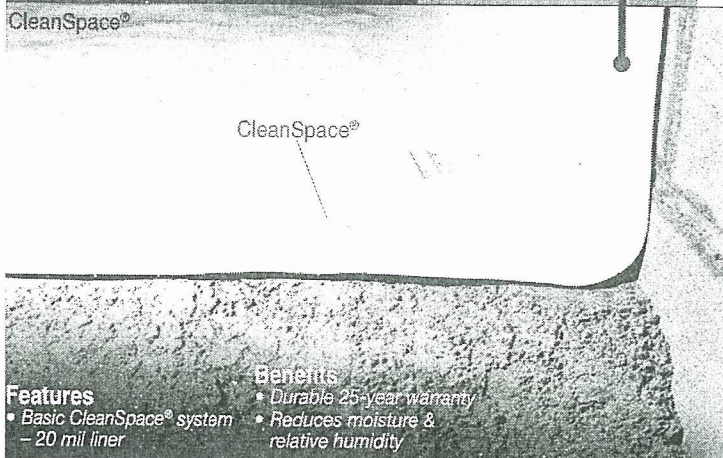
crawl spaces  
**WITHOUT**  
water leakage

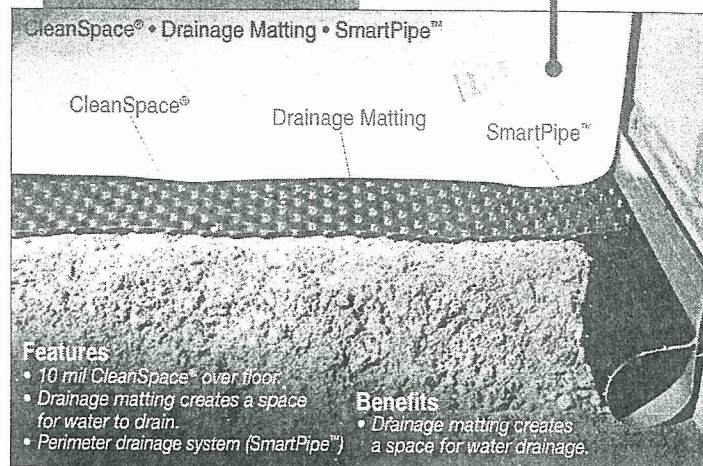
crawl spaces  
**WITH**  
water leakage
